## **Incident Report**

- Date of Incident: April 24th, 2024
- Time of Incident: Approximately 9pm local time
- Location: On-site at the shop area designated for vehicle installations, specifically outside the shop bays.

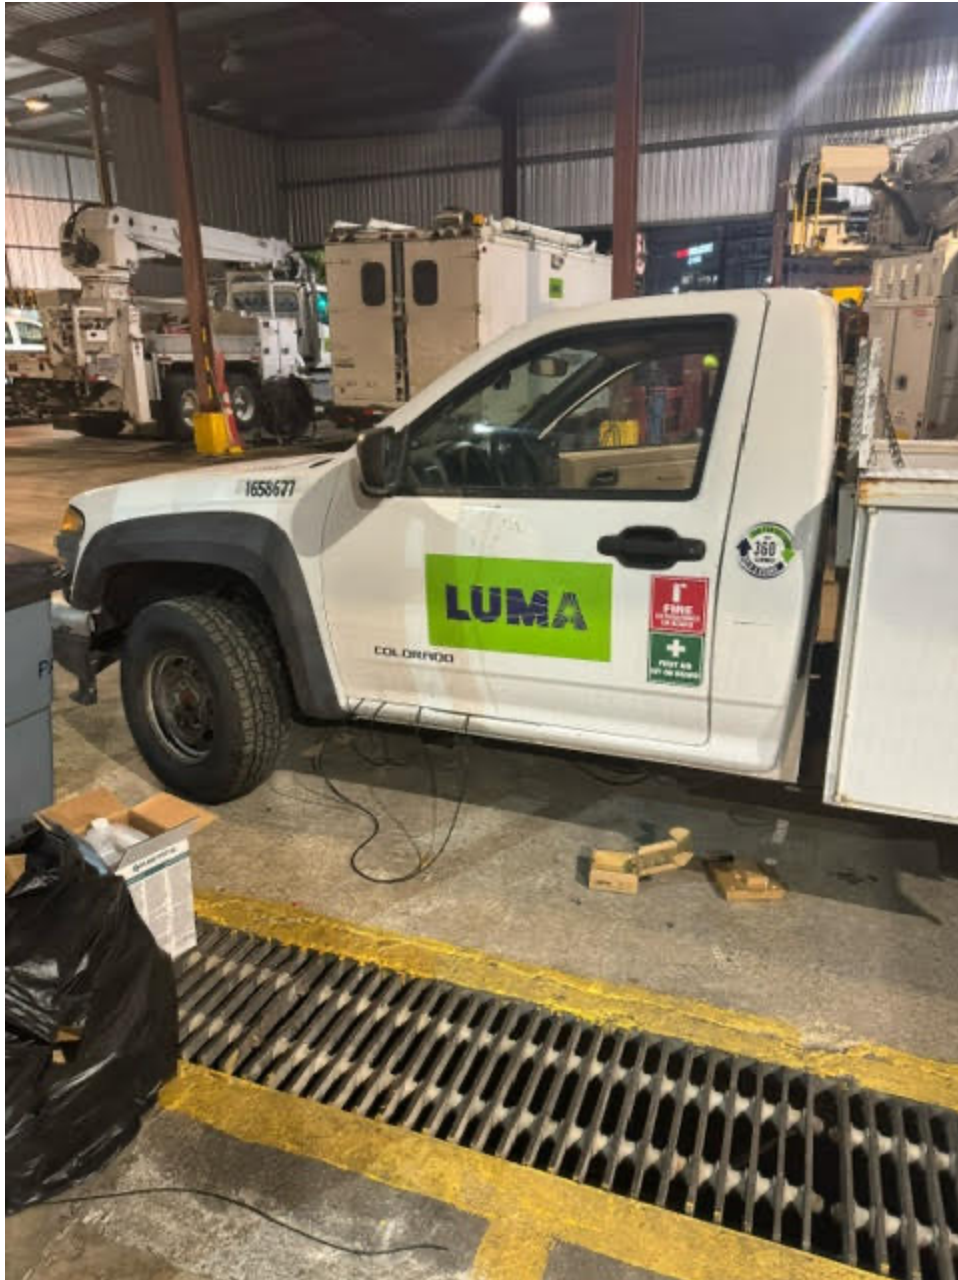
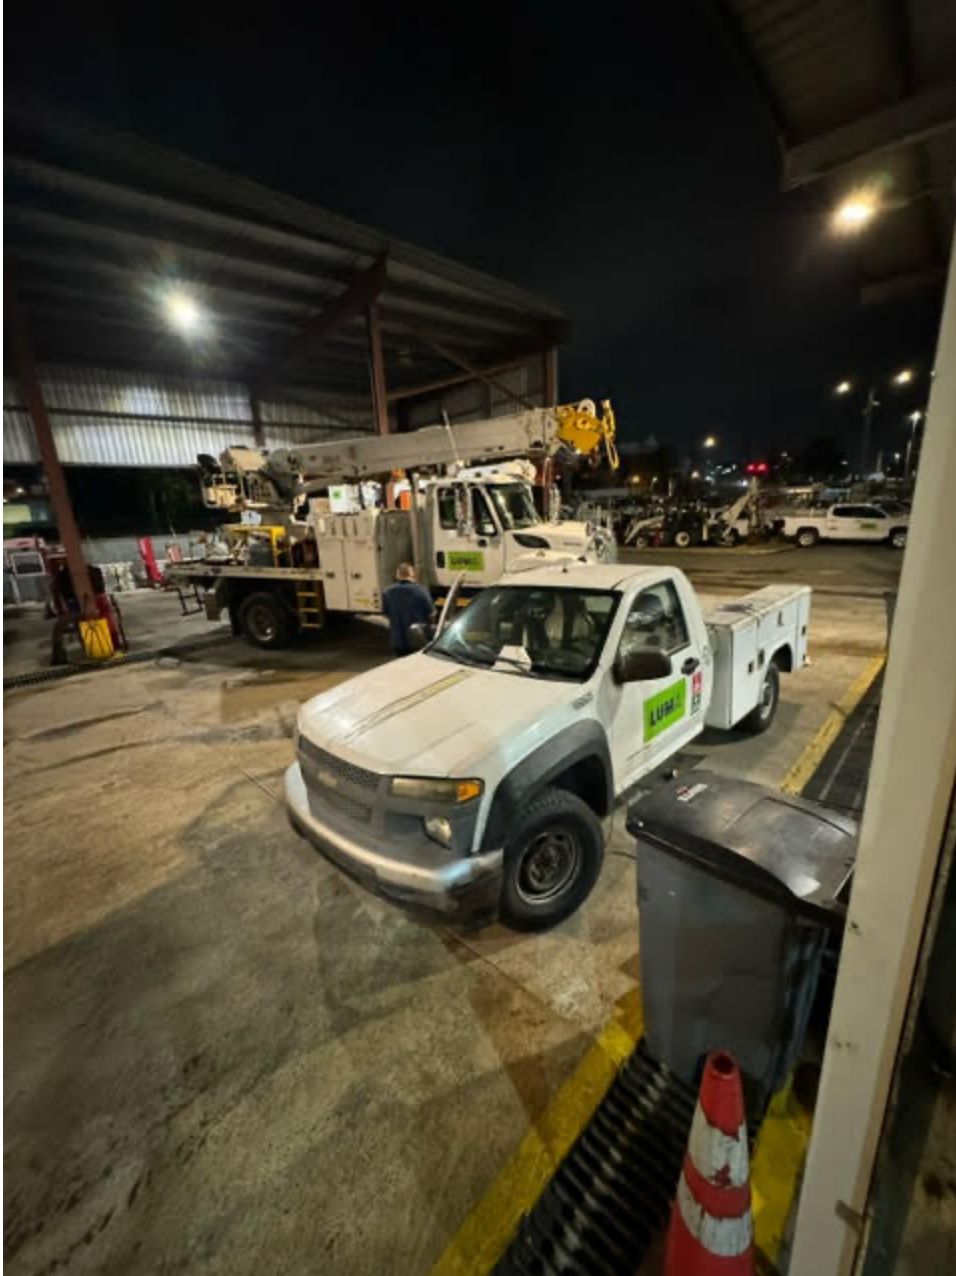
- Immediate Context: Daniel was working on installing a Motive camera in a smaller vehicle (Colorado) parked not inside but adjacent to the shop bays in an area with limited space due to several vehicles parked.
- Sequence of Events: While Daniel was working under the dash on his knees, a large truck (International) was being parked in a nearby bay. The truck's passenger side front bumper collided with the Colorado's rear corner, shifting it and impacting Daniel's bent knee.

- Environmental and Operational Conditions: The incident occurred in a congested area where several vehicles were parked close to each other, limiting the space available for maneuvering large vehicles. This setup was a significant factor contributing to the incident.

- Immediate: Reassess and enforce stricter guidelines for vehicle movement within the shop areas, especially when installations are in progress.
- Long-term: Conduct regular safety drills and revisits safety protocols with all staff, focusing on emergency response and spatial awareness in congested areas.

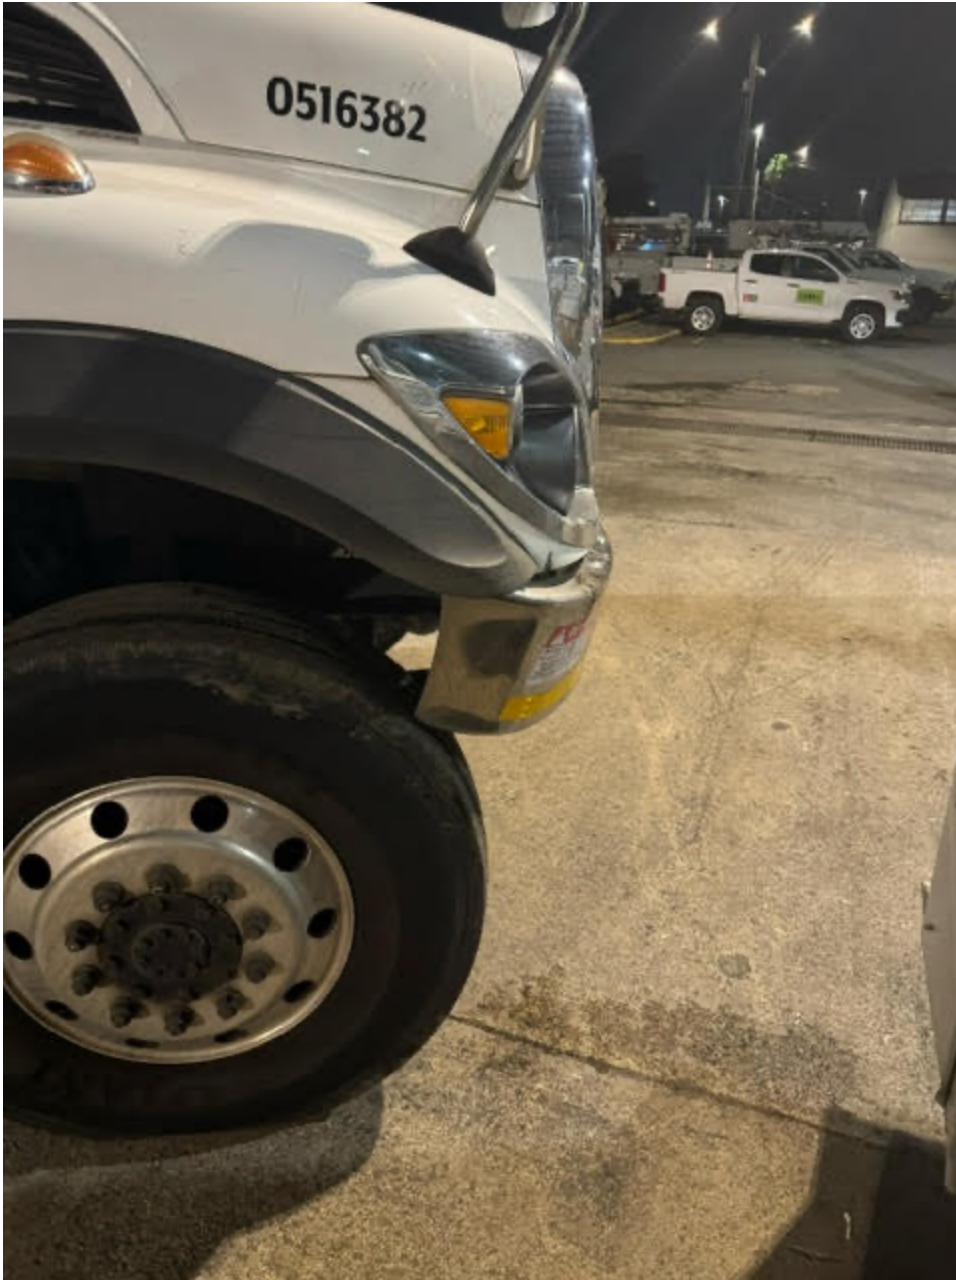
- Note the damage to the front bumper of the International
